UNDERWATER BRIDGE INSPECTION REPORT

STRUCTURE NO. 5411

MINNESOTA RIVER

MINNESOTA DEPARTMENT OF TRANSPORTATION
UNDERWATER BRIDGE INSPECTION

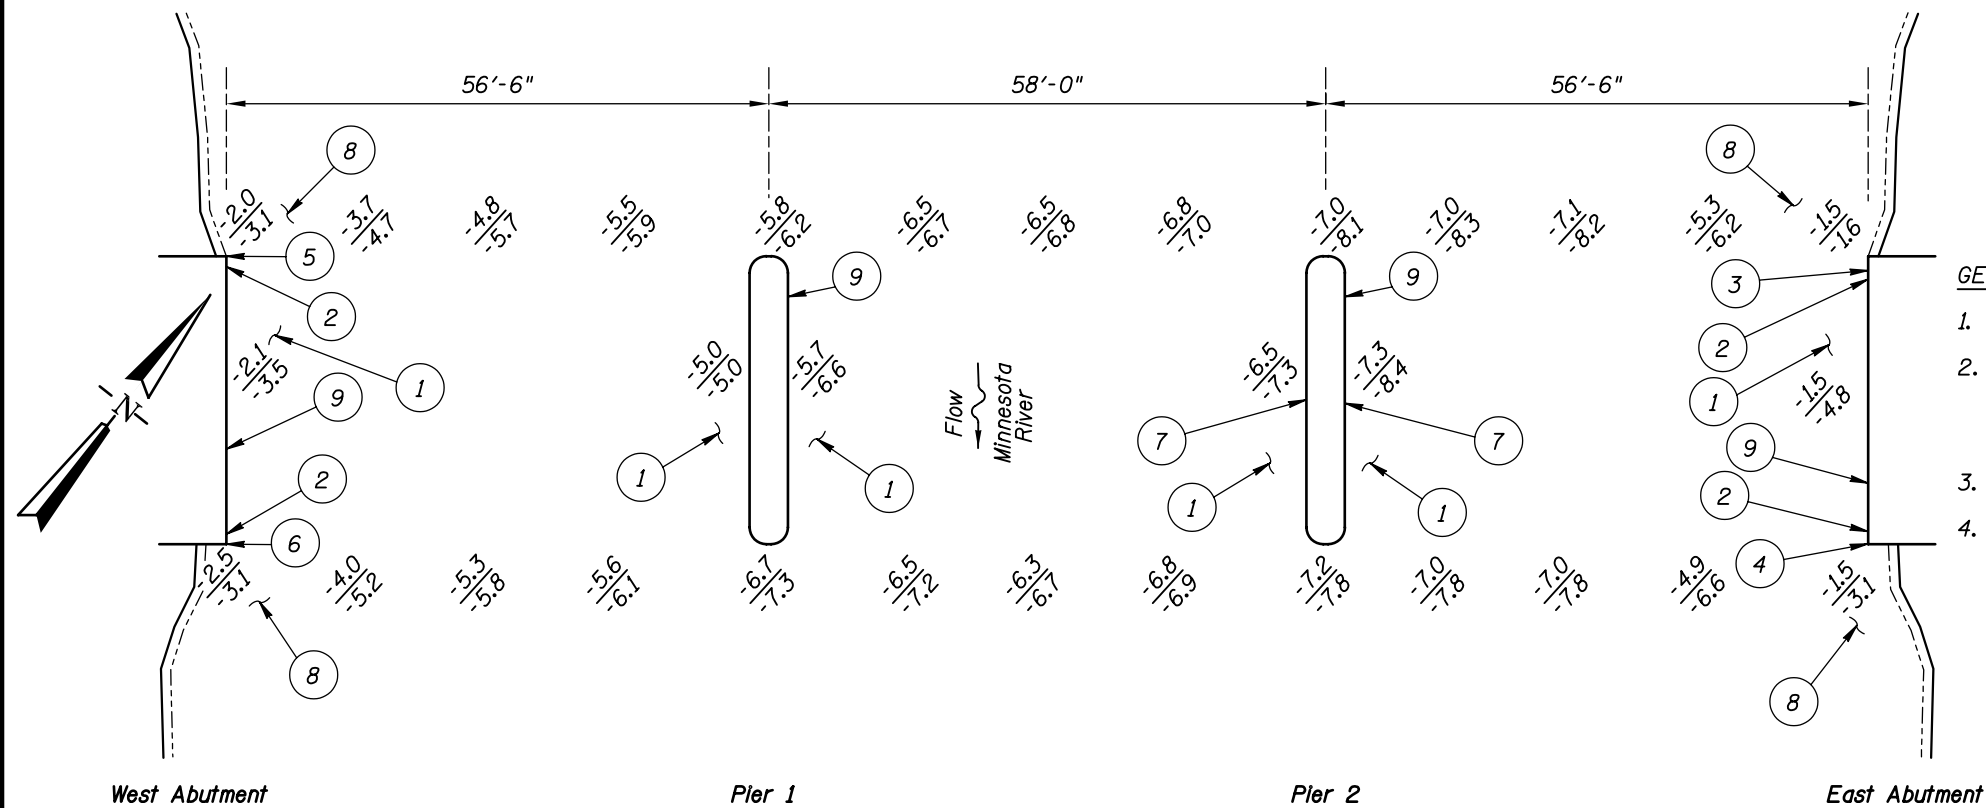
INSPECTION AND SOUNDING PLAN

- 1 The channel bottom consisted of silt and sand with up to 6 inches of probe rod penetration.
- 2 Minor hairline cracks with efflorescence on the corners of the abutments extending from the top of the abutment to the waterline.

- 3 Area of section loss, 6 inches high with 4 inches of penetration located 4 feet above the waterline.
- 4 Area of section loss, with exposed reinforcing steel, 3 feet wide with 6 inches of penetration extending from the waterline to 2.5 feet above the waterline.

- 5 Area of section loss, 6 inches high with 3 inches of penetration located 3 feet above the waterline.
- 6 Mapcracking and impending section loss with exposed reinforcing steel, at top of cap measuring 12 inches wide by 3 inches high at 2 feet above the waterline.

- 7 Vertical hairline crack extending from the top of the cap to the waterline.
- 8 The channel bottom material around the corners of the abutments consisted of 1 to 2 foot diameter riprap.

- 9 Below water, the concrete was in good and sound condition.

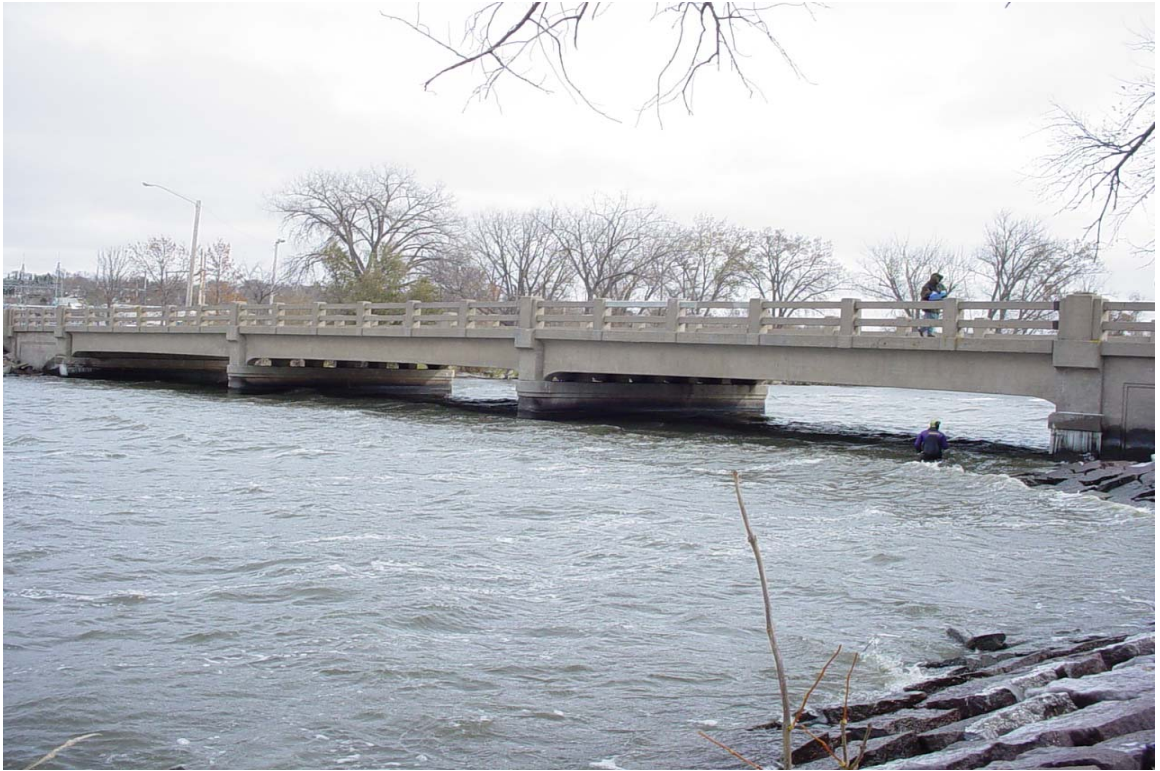
Photograph 1. Overall View of Structure, Looking East.

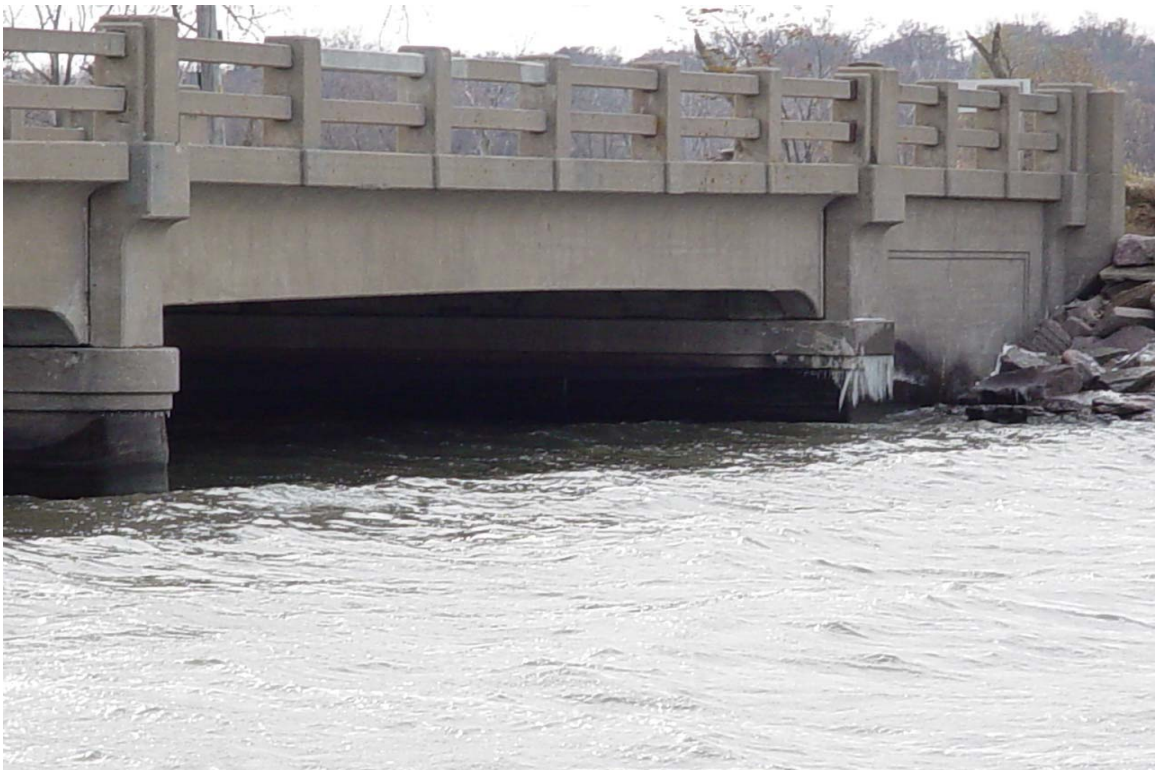
Photograph 2. View of West Abutment, Looking South.

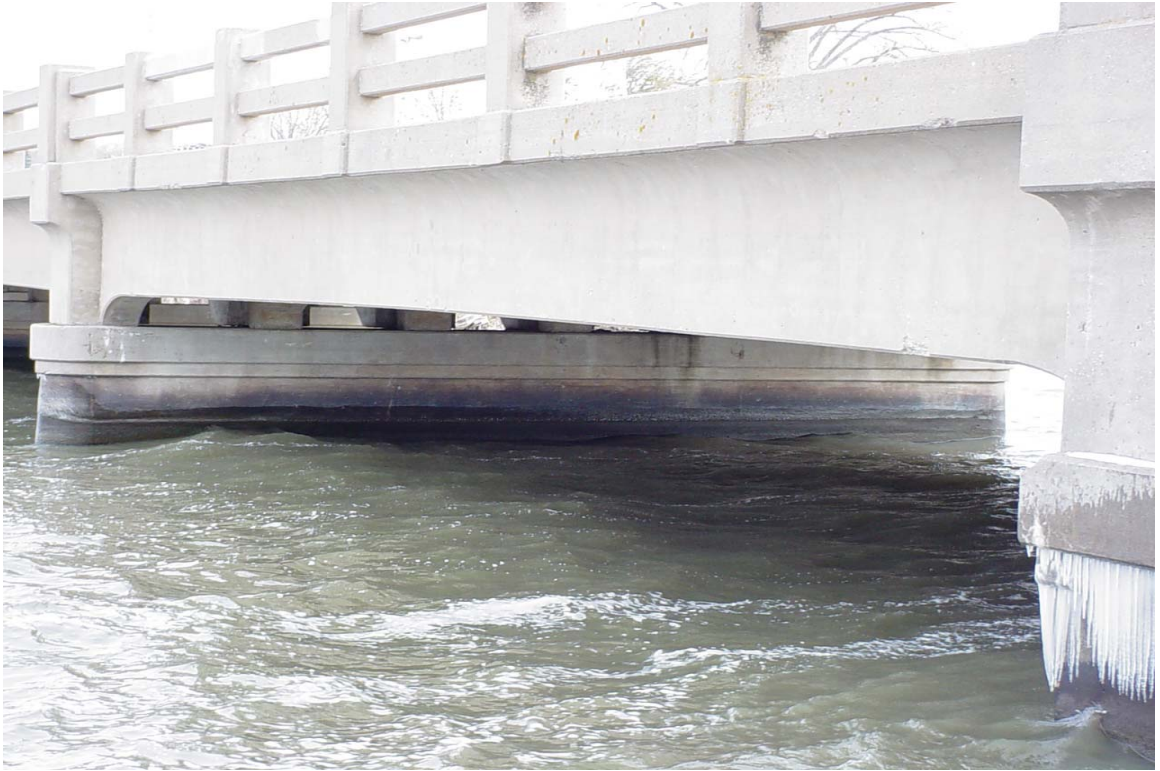
Photograph 3. View of Pier 1, Looking East.

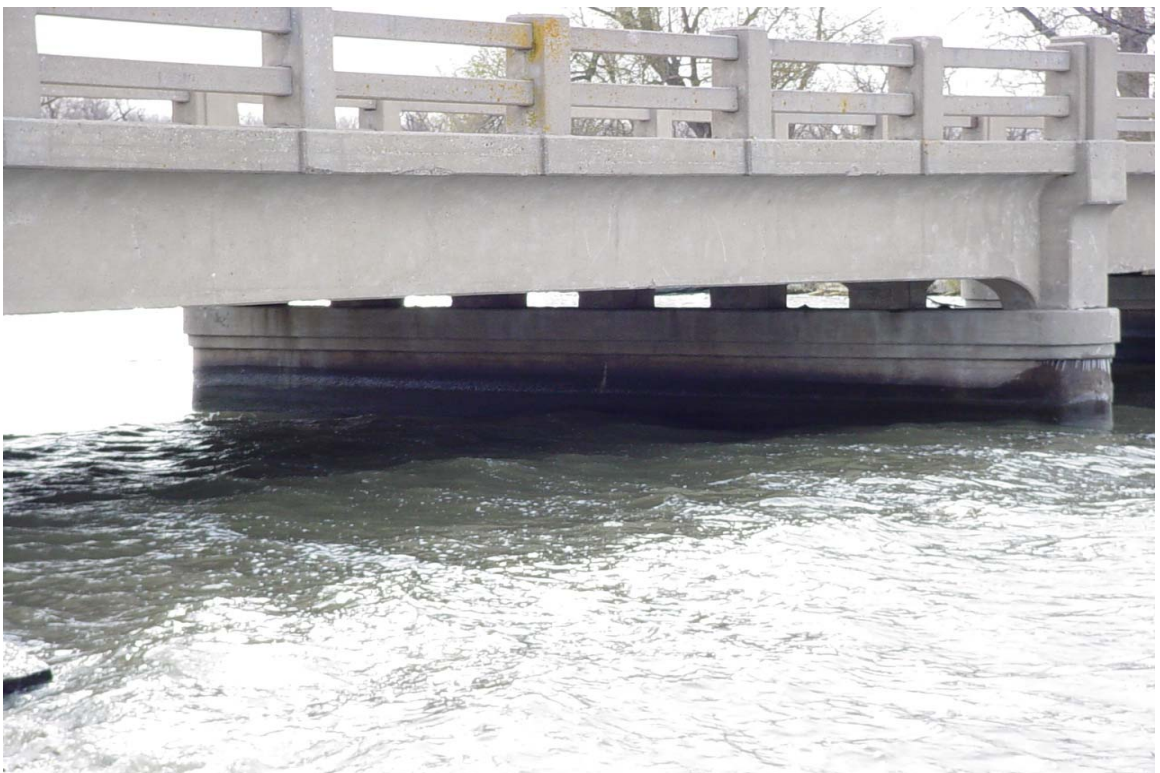
Photograph 4. View of Pier 2, Looking South.

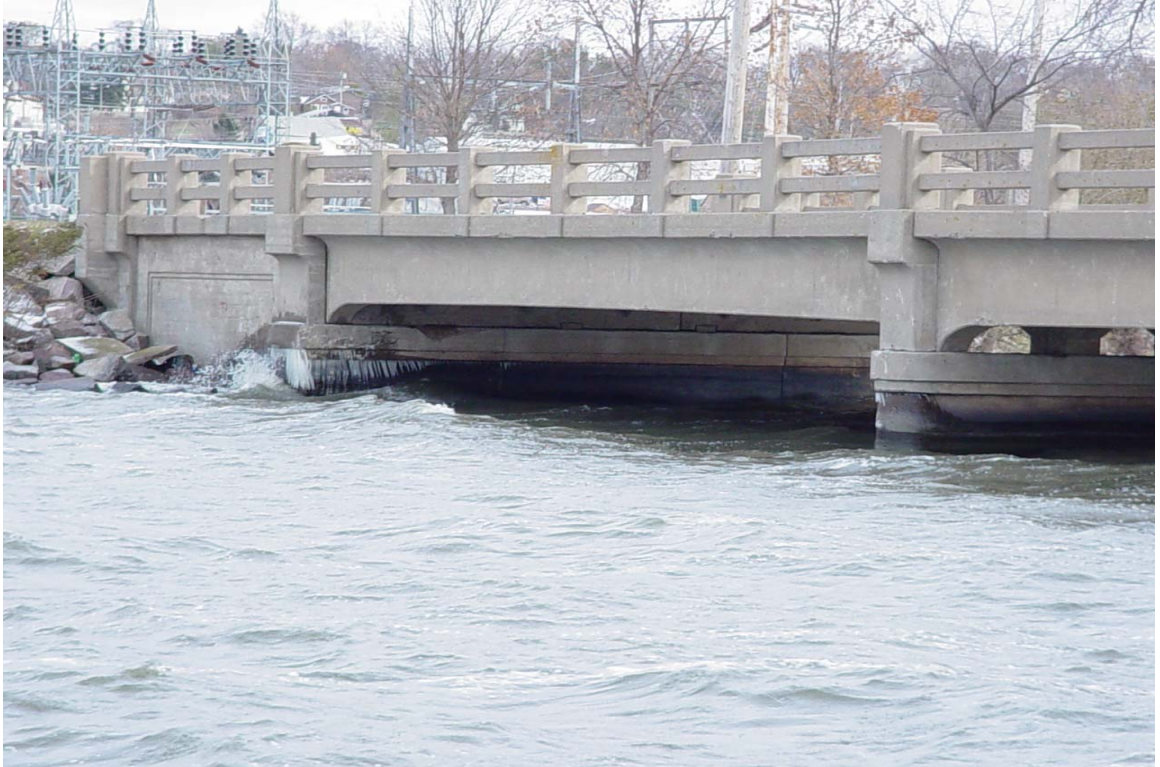
Photograph 5. View of East Abutment, Looking East.

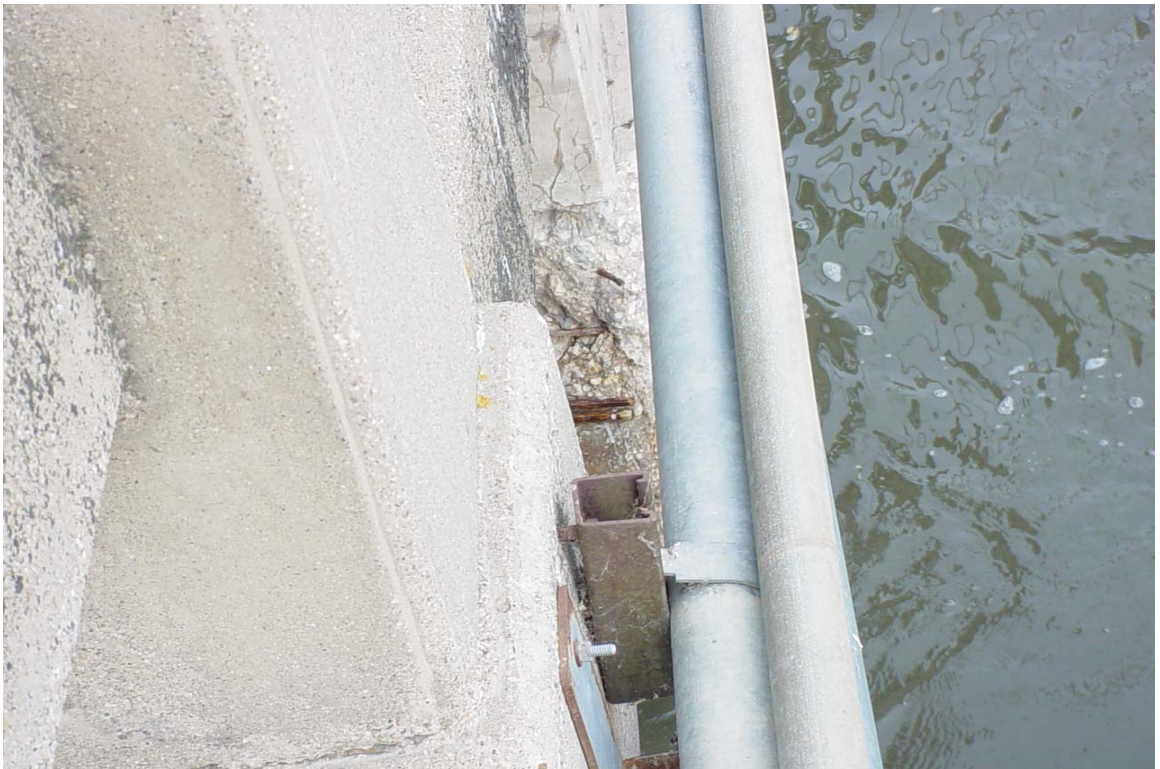
- (B) Several areas of section loss were observed above the waterline on the corners of the East and West Abutments. The areas of section loss at the north corner of the West Abutment and the south corner of the East abutment also exhibited exposed reinforcing.

Photograph 6. View of the South Corner of the East Abutment with Area of Section Loss and Exposed Reinforcing, Looking East.

- (A) Monitor the areas of section loss with exposed reinforcing steel during future inspections, and if found to be progressing, repairs may be warranted at a later date.
- (B) Reinspect the submerged substructure units at the normal maximum recommended (NBIS) interval of five (5) years.
